Canyon Lake East Bay Sedimentation Characterization

Prepared For :
Lake Elsinore & San Jacinto Watersheds Authority

August 2002

CANYON LAKE EAST BAY SEDIMENTATION CHARACTERIZATION STUDY

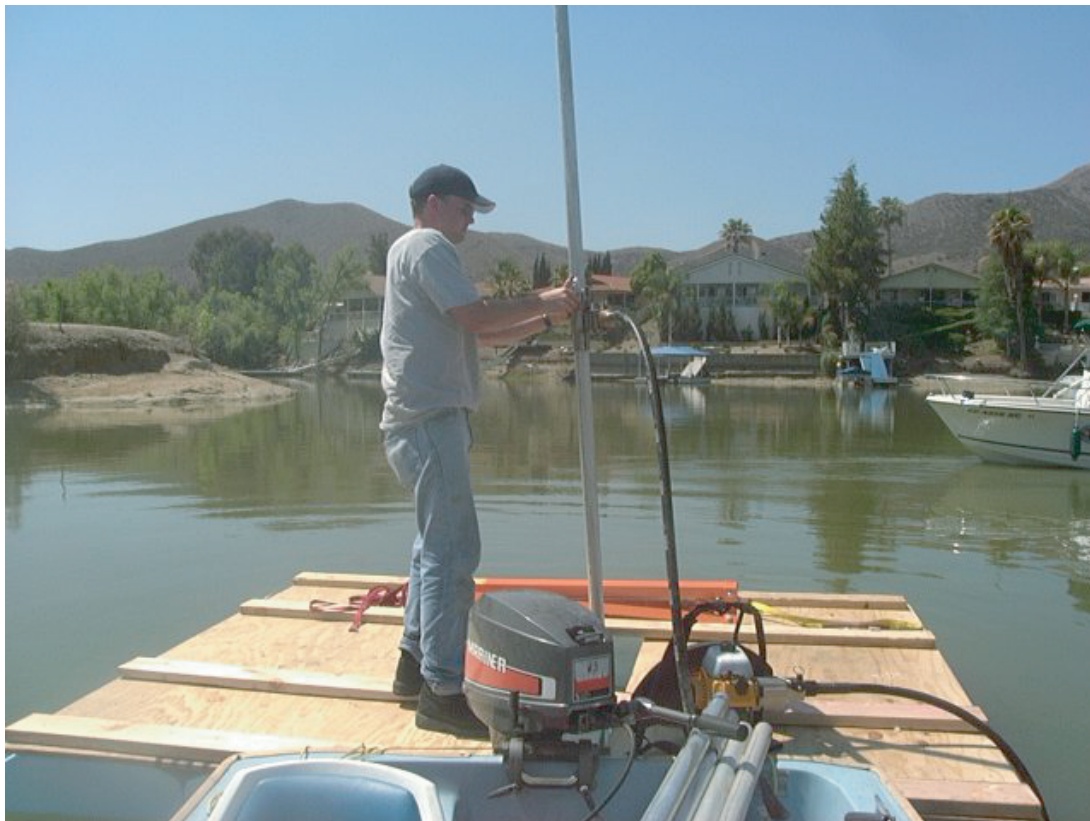
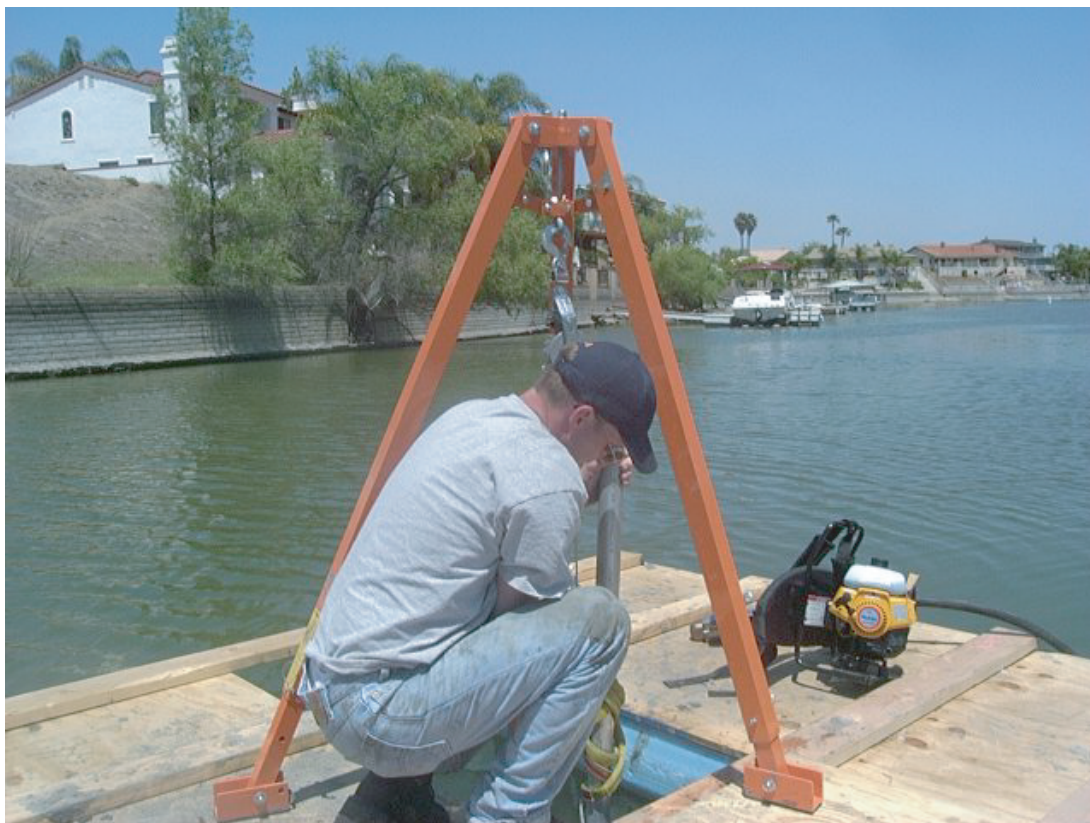
FIGURE 4
Vibracoring Photos
 Canyon Lake East Bay Sediment Characterization
 Lake Elsinore and San Jacinto Watersheds Authority

On May 29, 2002, core samples were obtained at each location utilizing the vibacore methodology. During this innovative procedure, dedicated 2-inch diameter aluminum core barrels were vibrated into the lake bottom until refusal at each site (Figure 4). Core barrel penetration is greatest within water-saturated sediments such as sand and silt. Consolidated sediments, such as clay or rock, restrict the core barrel from penetrating and may be used as a plug for retaining sediment within the core barrel. As anticipated, the natural base of the fluvial system at Canyon Lake consists of clay and was used as a plug. The excess core barrel above the water line was cut off using a hacksaw and retained for later disposal. The top of each core barrel was filled with water, capped, and winched out of the bottom of the lake by a floating platform, tripod, and hand winch. Recovery at each site was noted, and each core was measured, labeled, and capped in the field after collection.

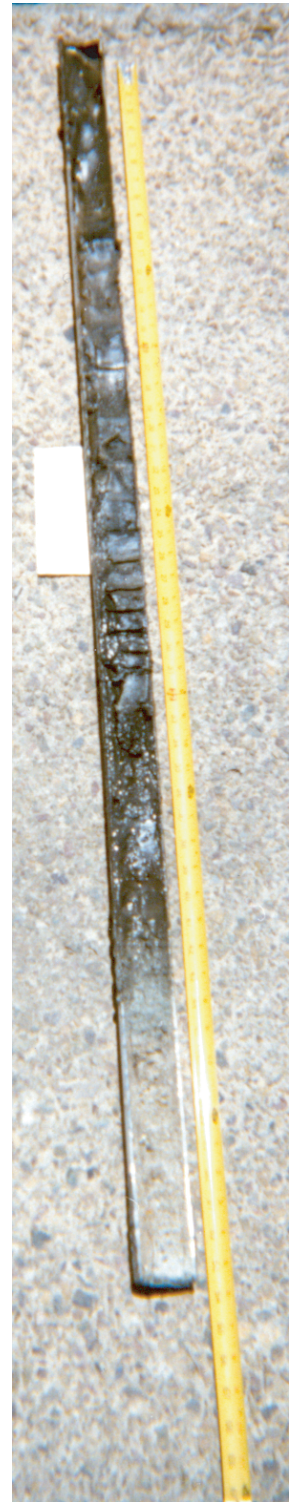
Core 1

CORE ID: CORE 1	CORE DATE: 29 MAY 02	TIME: 0935 HOURS	LOG DATE: 01 JUNE 02
RECOVERY: 5' 6"	WATER DEPTH: 5' 7"		
SAMPLE INTERVAL	SOIL PROFILE	ASTM SYMBOL	DESCRIPTION
0-43"		OH	Dark gray mud, very soft, wet, organic rich, no sand content
43" - 54"		CL	Light brown (tan) sandy clay, moist, tight, trace coarse sand
CORE ID: CORE 2	CORE DATE: 29 MAY 02	TIME: 1037 HOURS	LOG DATE: 01 JUNE 02
RECOVERY: 5' 7"	WATER DEPTH: 6'		
SAMPLE INTERVAL	SOIL PROFILE	ASTM SYMBOL	DESCRIPTION
0-43"		OH	Dark gray mud, very soft, wet, organic rich, no sand content
43" - 56"		CL	Brown sandy clay, tight, moist, gravel at 49"
56" - 67"		SP	Dark gray sand, poorly graded, moist, trace coarse sand/clay
CORE ID: CORE 3	CORE DATE: 29 MAY 02	TIME: 1137 HOURS	LOG DATE: 01 JUNE 02
RECOVERY: 4' 7"	WATER DEPTH: 9' 10"		
SAMPLE INTERVAL	SOIL PROFILE	ASTM SYMBOL	DESCRIPTION
0 - 42"		OH	Dark gray mud, very soft, wet, organic rich, no sand content

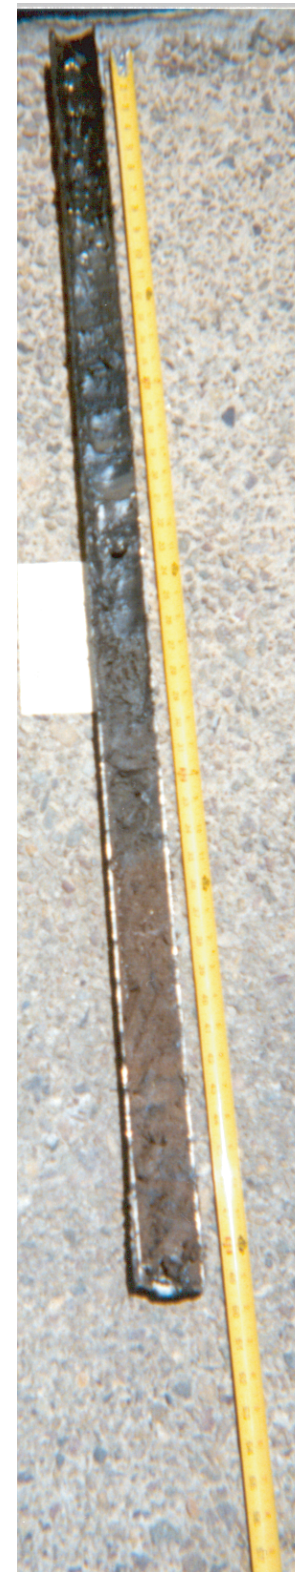
Core 4

42" - 47"		CL	Light green sandy clay, moist
47" - 55"		CL	Light brown sandy clay, moist, tight, trace coarse sand
CORE ID: CORE 4	CORE DATE: 29 MAY 02	TIME: 1217 HOURS	LOG DATE: 01 JUNE 02
RECOVERY: 4' 1"	WATER DEPTH: 7'		
SAMPLE INTERVAL	SOIL PROFILE	ASTM SYMBOL	DESCRIPTION
0 - 30"		OH	Dark gray mud, very soft, wet, organic rich, no sand content 0 - 27", 27 - 30" trace sand
30" - 35"		CL	Dark gray clay, moist, tight, trace fine sand, gravel at 34"
35" - 49"		CL	Reddish-brown sandy clay, moist, soft
CORE ID: CORE 5	CORE DATE: 29 MAY 02	TIME: 1305 HOURS	LOG DATE: 01 JUNE 02
RECOVERY: 2' 4"	WATER DEPTH: 6' 11"		
SAMPLE INTERVAL	SOIL PROFILE	ASTM SYMBOL	DESCRIPTION
0 - 20"		OH	Dark gray mud, very soft, wet, organic rich, 7.5-10.5" brown clayey sand, wet, gravel at 8", grayish green clayey sand, wet, trace gravel
20" - 25"		SC	Grayish green clayey sand, wet, trace gravel
25" - 28"		CL	Gray clay, moist, tight, trace fine sand

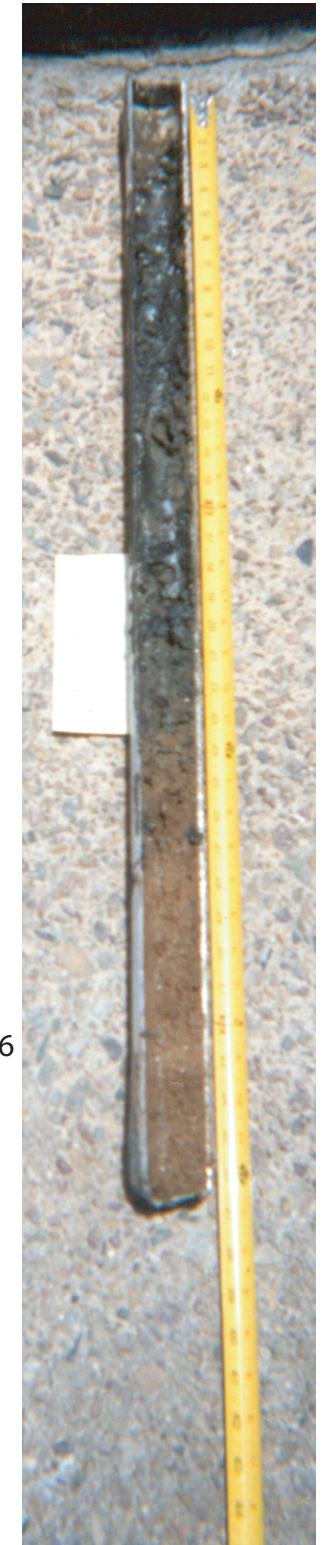
Core 6

CORE ID: CORE 6	CORE DATE: 29 MAY 02	TIME: 1345 HOURS	LOG DATE: 01 JUNE 02
RECOVERY: 3' 1"	WATER DEPTH: 8' 1"		
SAMPLE INTERVAL	SOIL PROFILE	ASTM SYMBOL	DESCRIPTION
0 - 21"		OH	Dark gray mud, very soft, wet, organic rich, clay interval 14-17"
21" - 24"		CL	Dark gray sandy clay, moist, soft, organic rich
24" - 37"		CL	Reddish-brown sandy clay, moist, soft
