# **State of Lake Elsinore**

**February 21, 2019**

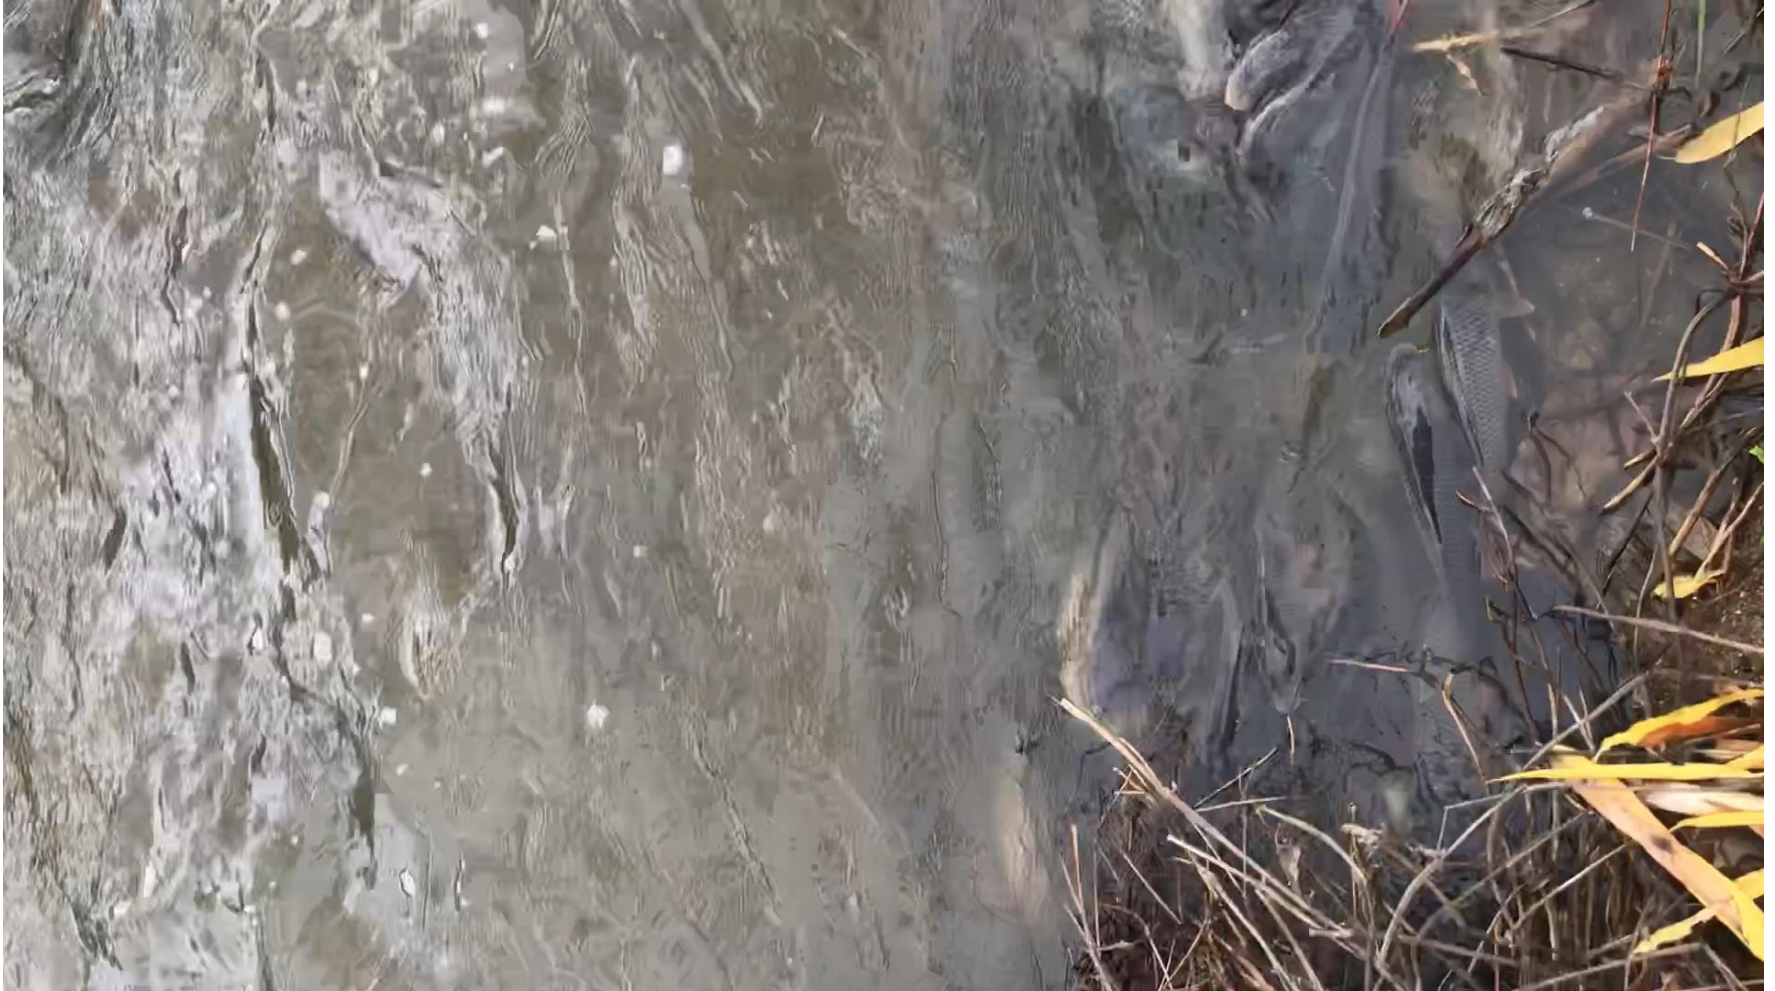
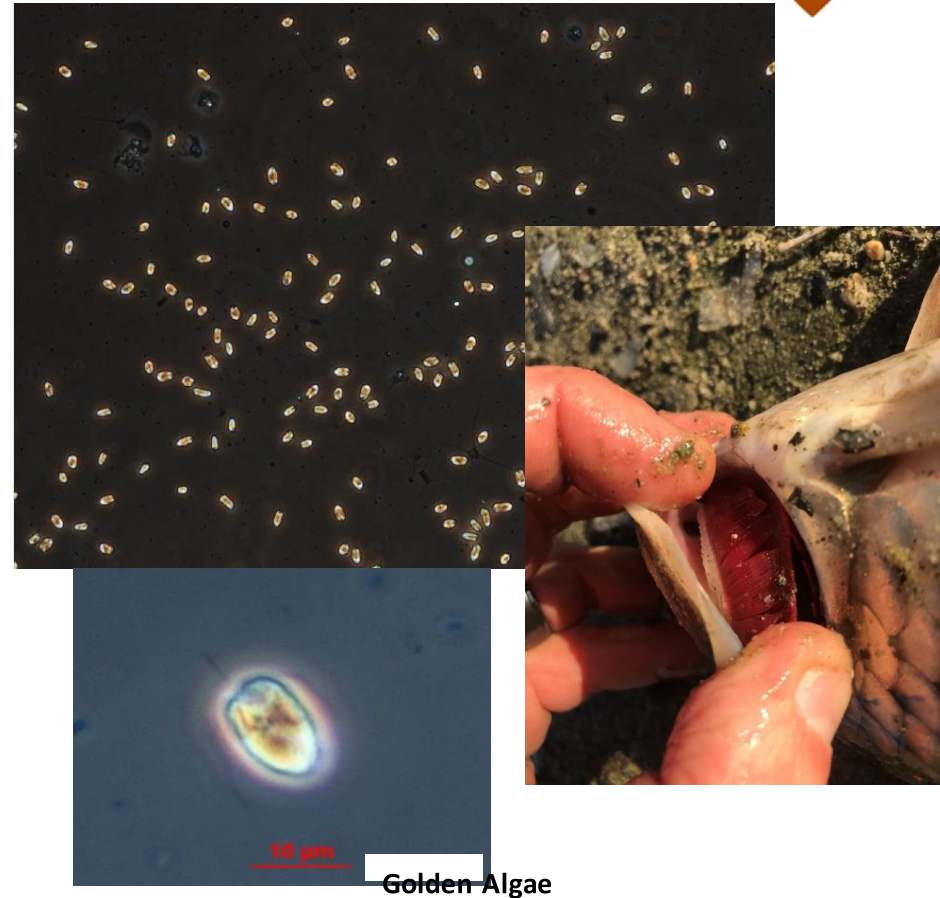
# What Happened: Golden Algae

- First time documented in LE
- January 9<sup>th</sup> Water Samples
  - Golden Algae at HIGH concentrations
  - 10 to 12 times highest algae
- First time documented in LE
- Signs of Golden Algae
  - Blooms in Winter Months
  - Prevalant in Urban Runoff Waters
  - Toxic to Fishery
- Toxicity Testing with Minnows – 100% Mortality

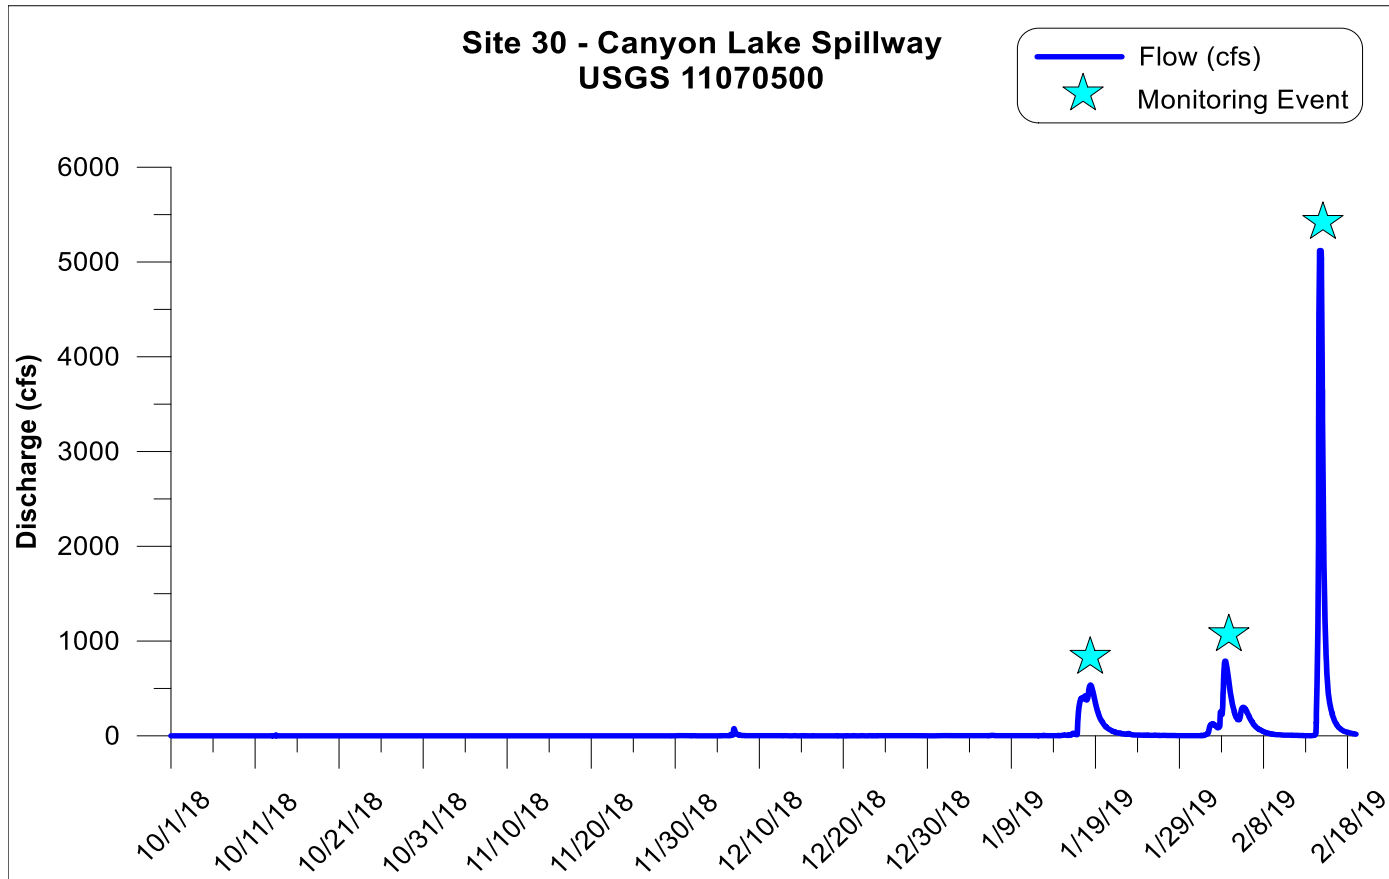
# Canyon Lake Spillway

Today:  
1381.75'

Spillway:  
1381.76'

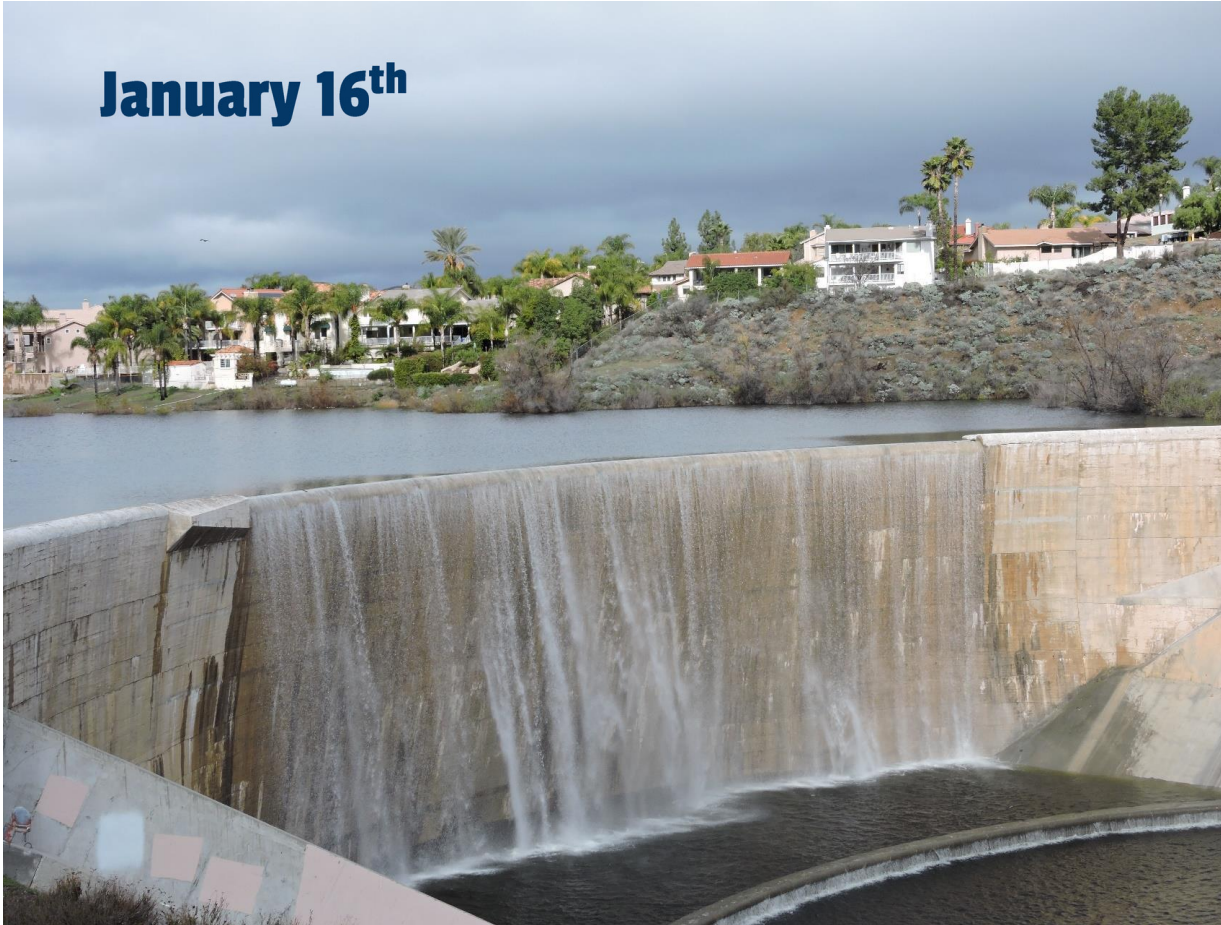
**January 16<sup>th</sup>**

# Canyon Lake Spillway

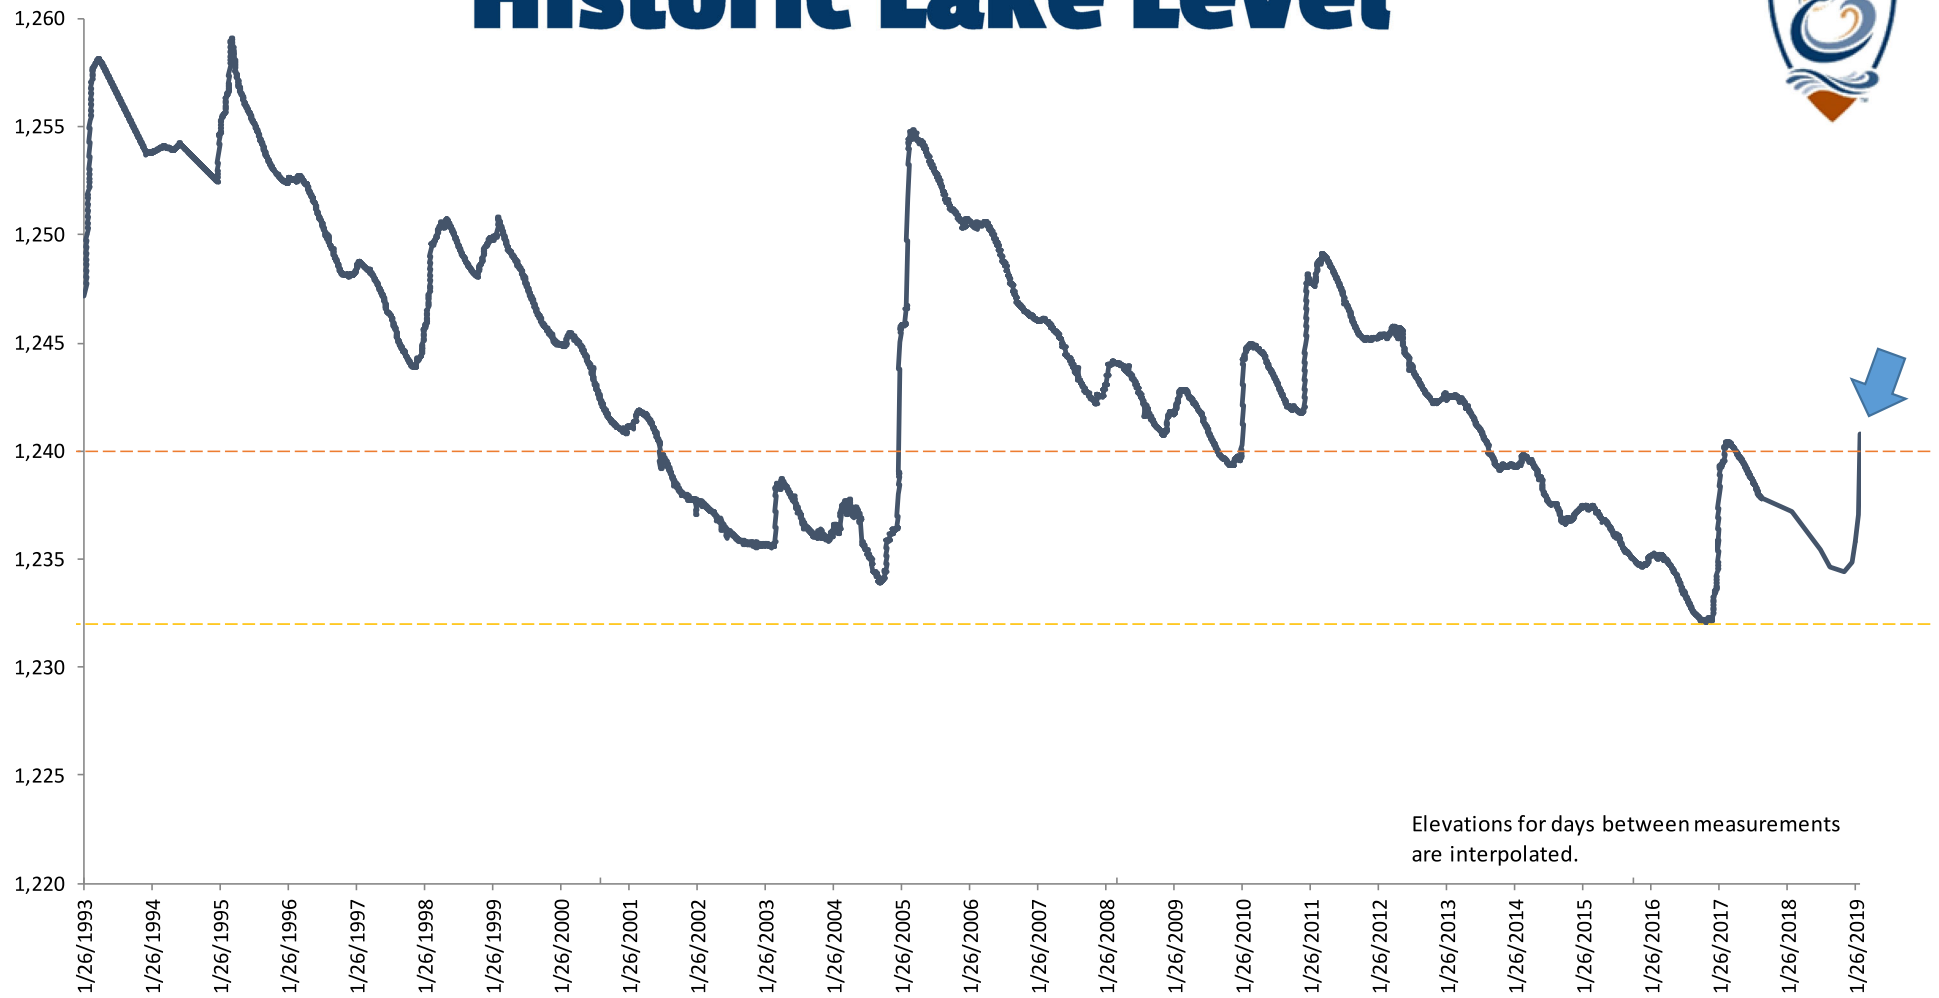
# Historic Lake Level

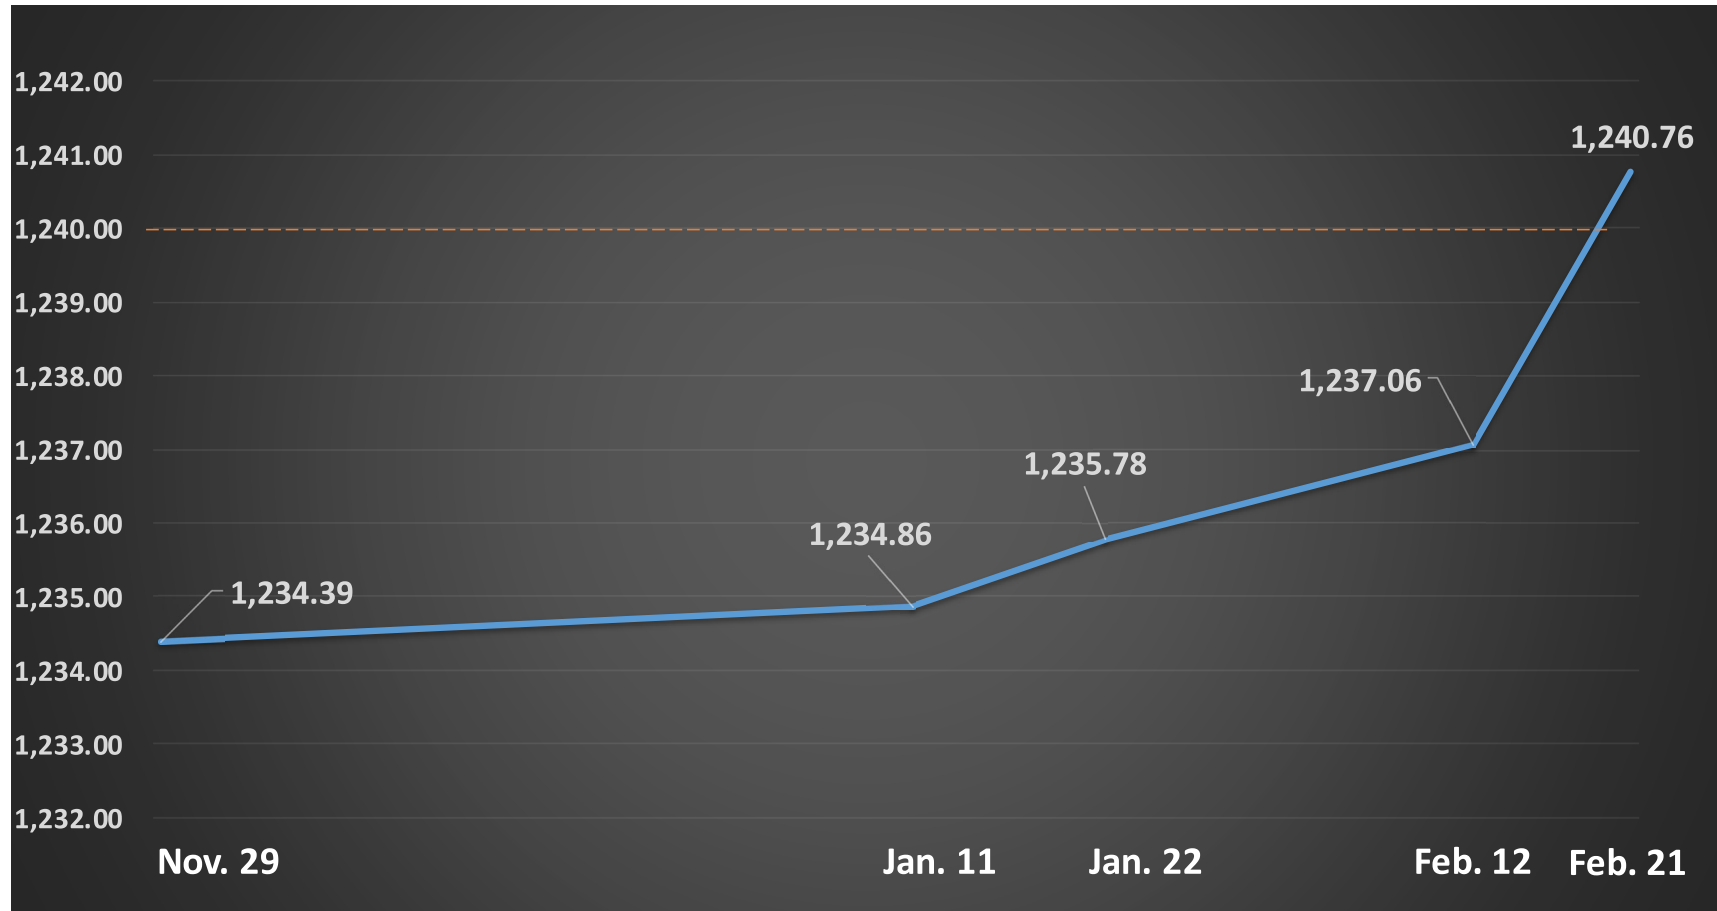
# Recent Lake Levels

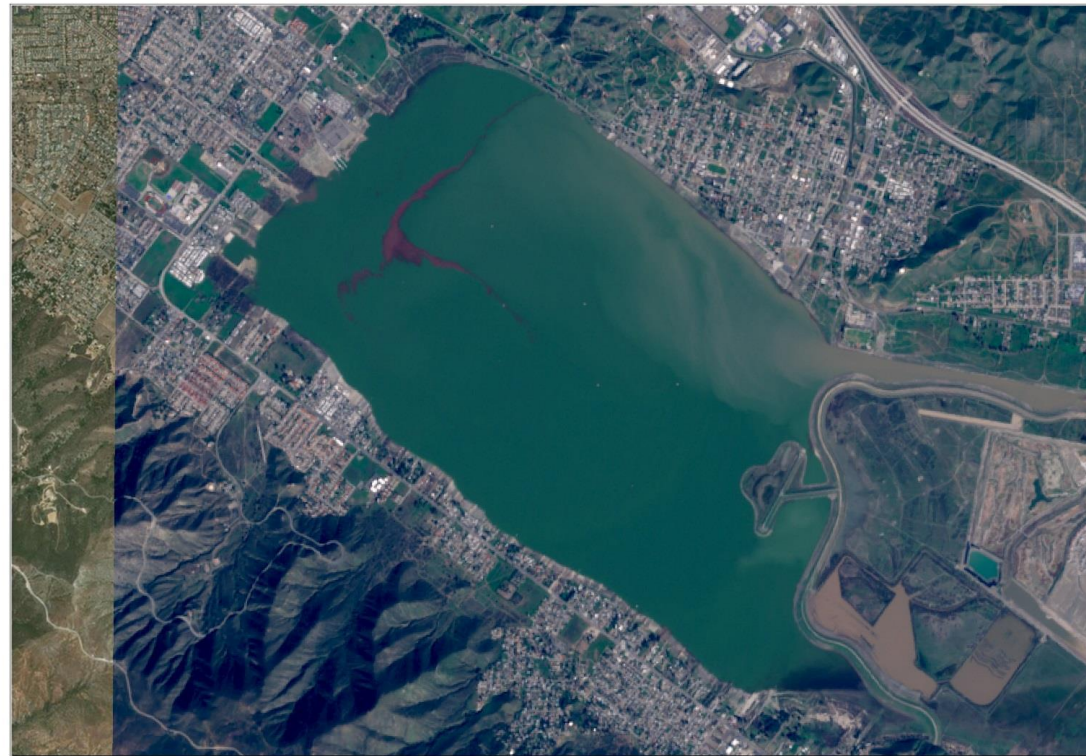
# Satellite Imagery of Lake Elsinore

**Satellite Imagery**  
**Lake Elsinore**  
**February 19, 2019 Satellite Flyover Event**

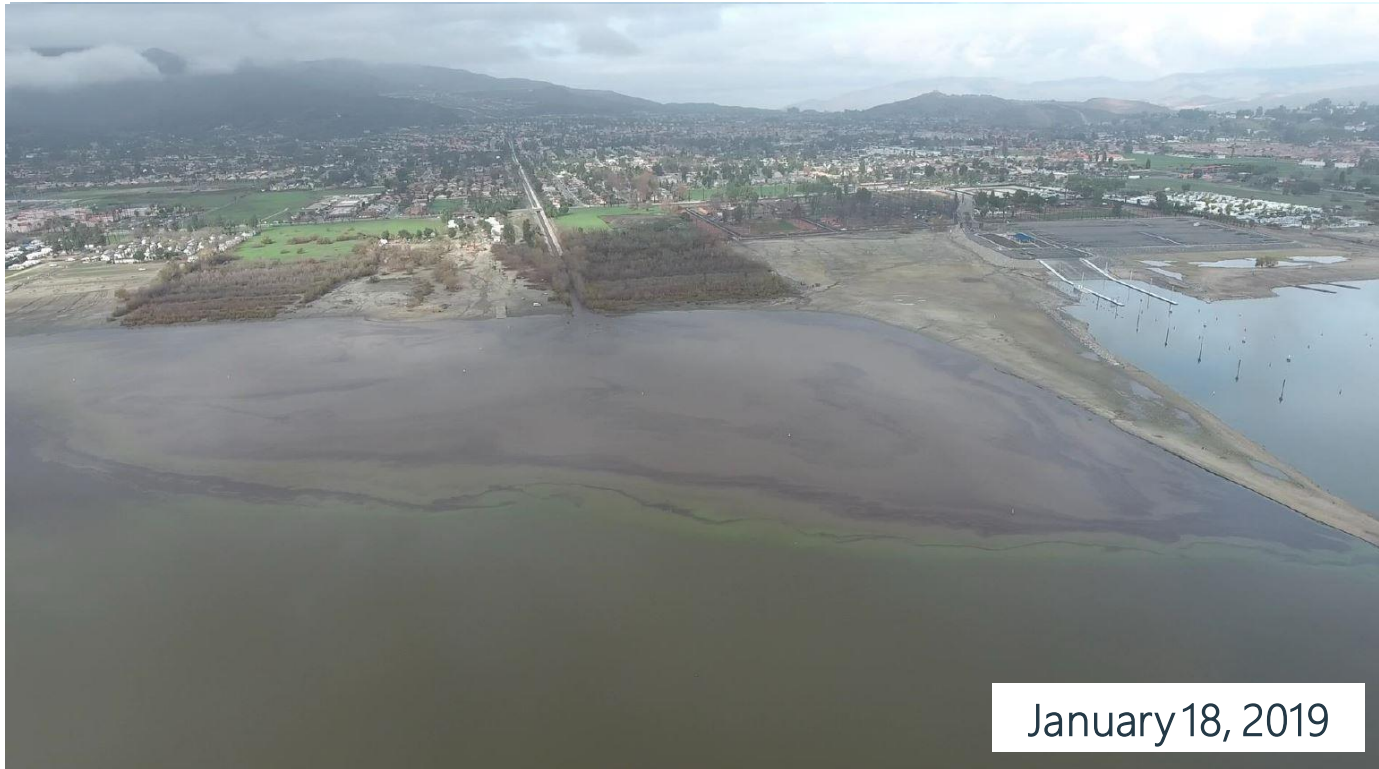
# Holy Flood Sediment Plume

- **Goal:** Dredge out sediment plumen
- Awaiting Sediment Chemistry Results
- Cleanup and Abatement Application Submitted Feb. 20
  - Comprehensive spatial analysis
  - Breadth and depth of plume
- Organizing Conference Call with Army Corps of Engineers
- City & County Continue State of Emergency
